OPERATIONS SAFETY NOTICE

OSN GEN-09-40

Alert Service Letter

Subject: Importance of ensuring the load beam is closed and locked before installing the mechanical release cable and setting the free play on TALON™ Keeperless style cargo hooks.

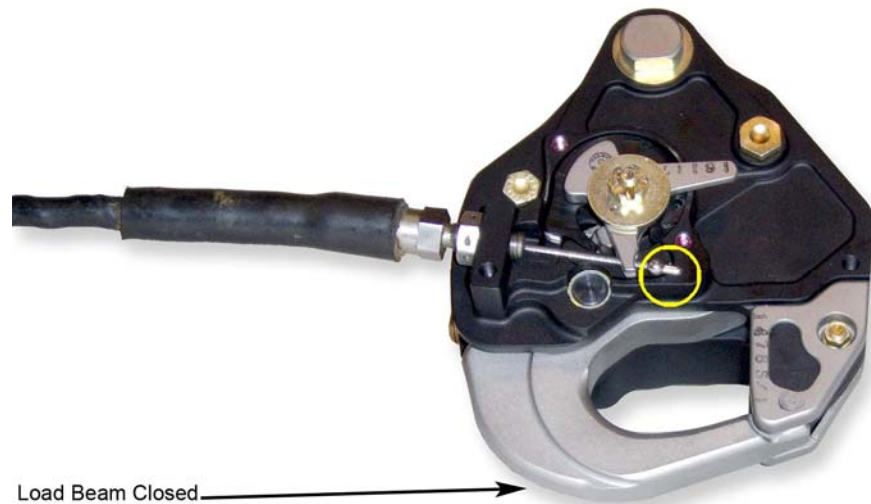
FIGURE 1

Picture of proper load beam position. The cargo hook load beam is fully closed and locked, ready to set the mechanical cable free play (circled in yellow).

It is critical that the load beam of the Onboard Systems TALON Keeperless style cargo hook is closed and fully locked before installation of the mechanical release cable and setting the cable free play. If the free play is set while the load beam is in the open position, when the load beam is closed it may reduce the amount of free play to an unsafe level that will not allow adequate margin of safety during external load operations. The reduced level of free play on the cable may result in inadvertently activating the release mechanism on the hook during operations, which could cause an inadvertent load release.

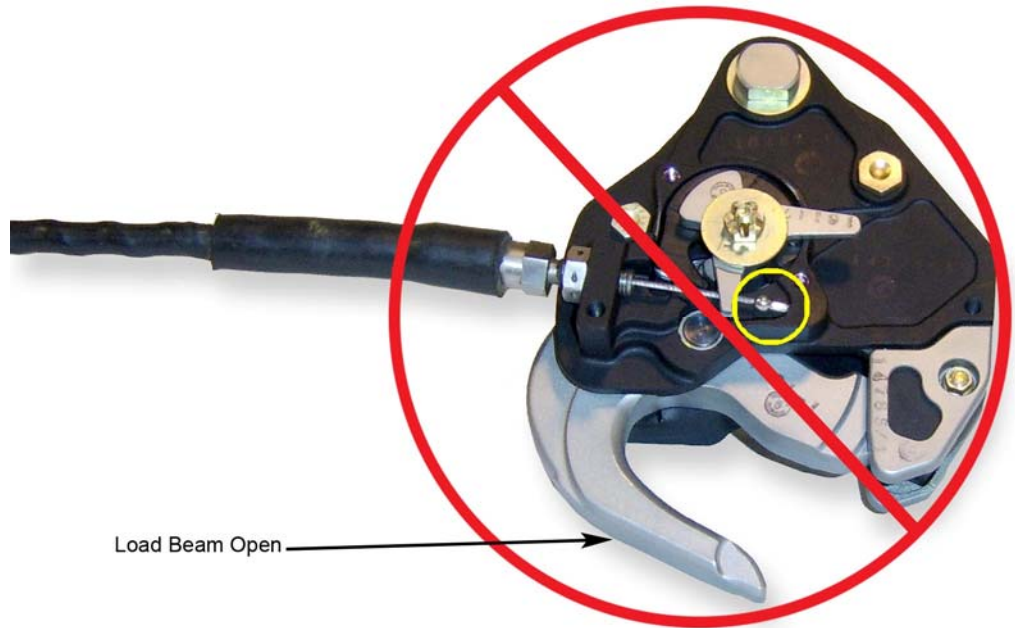
FIGURE 2

Picture of improper load beam position. The cargo hook load beam is open. If the mechanical cable free play is set now, there may not be enough free play in the cable (circled in yellow) when the hook is closed.
